**HOUSATONIC RIVER BASIN
TOWN OF AMENIA
DUTCHESS COUNTY, NEW YORK**

**THORNES DAM
NY 00793**

PHASE I INSPECTION REPORT

Thornes Dam (Inventory Number NY 00793).
Housatonic River Basin. Town of Amenia.
Dutchess County, New York. Phase I Inspection
Report.

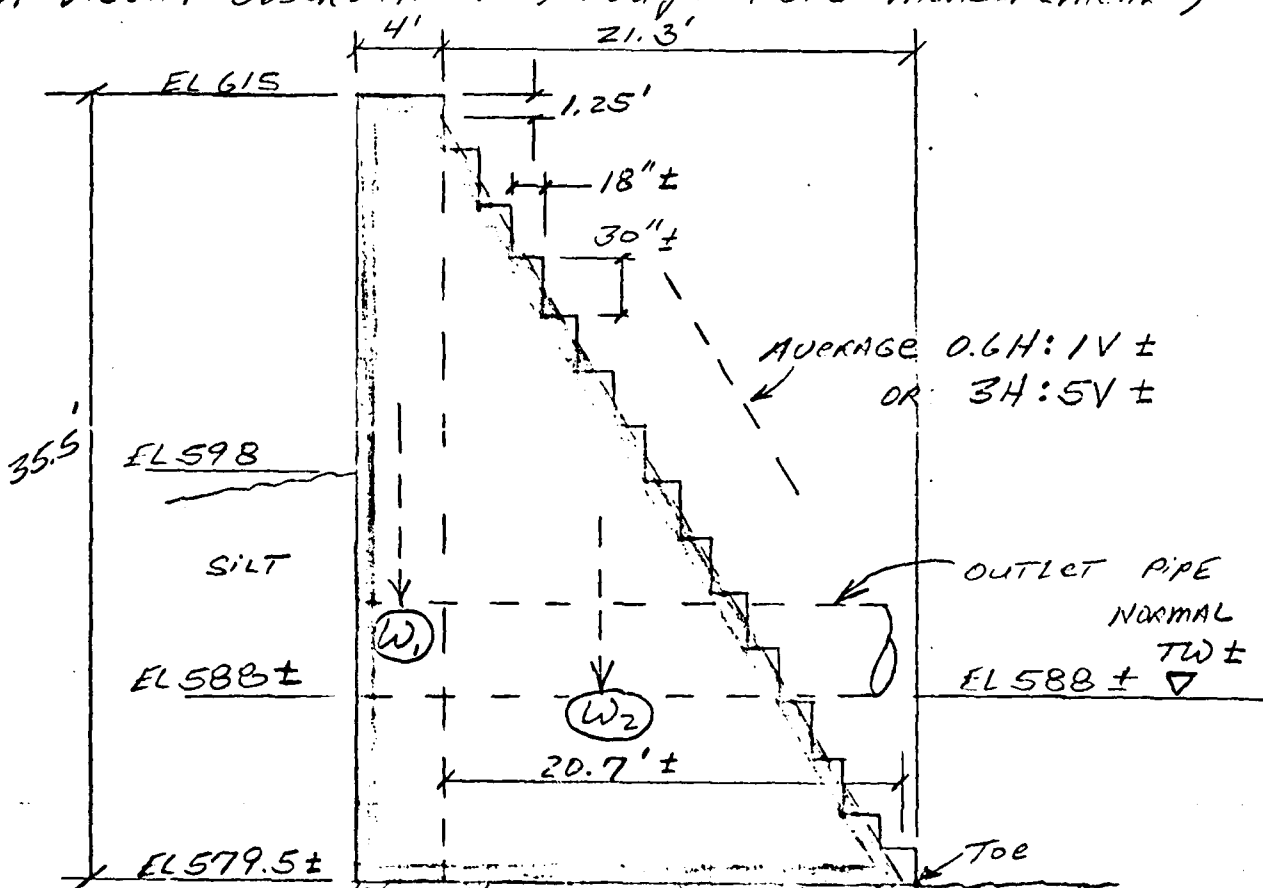
STABILITY ANALYSIS OF OVERFLOW SECTION

CROSS SECTION FOR ANALYSIS (At about $\frac{1}{2}$ of dam where unsupported height is max., dimensions based on visual observation & rough field measurement)

ROCK FOLIATIONS 40°

ASSUMED CRITICAL FAILURE PLANE FOR O/T & FOUNDATION DETAIL & SLIDING ALONG DAM/ROCK CONTACT

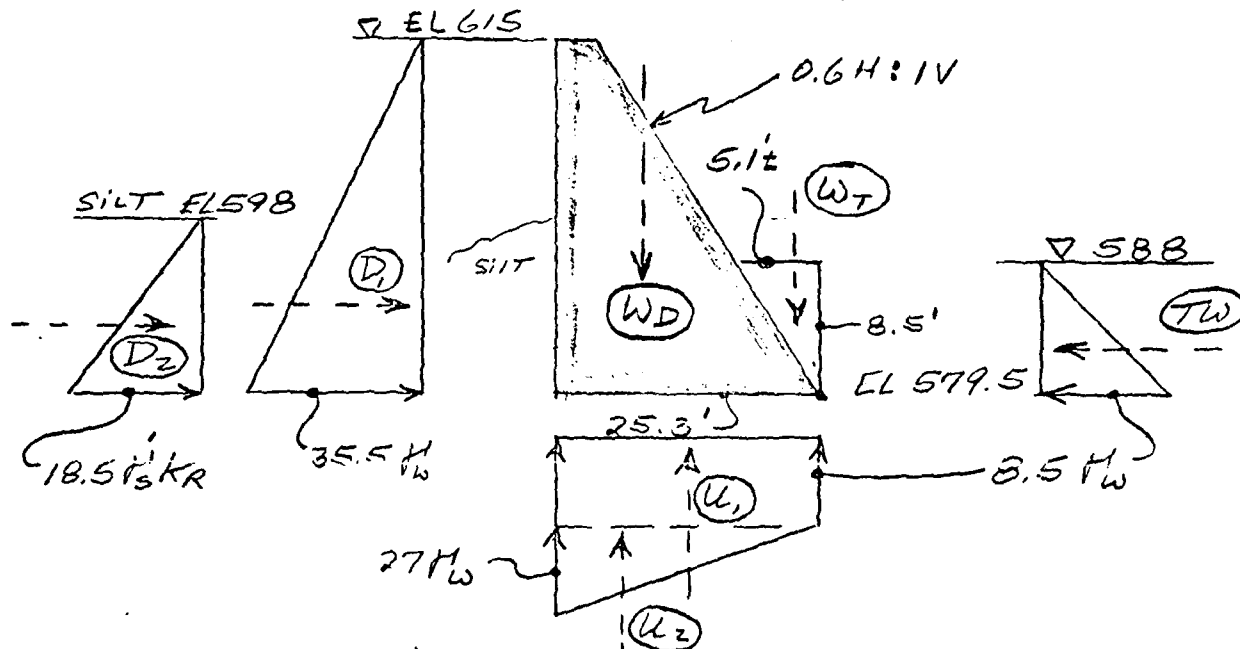
CASE 1 Normal pool at spillway crest, full HW & TW
uplift, silt 17' below crest by measurement,
TW about at outlet pipe by observation (8.5')

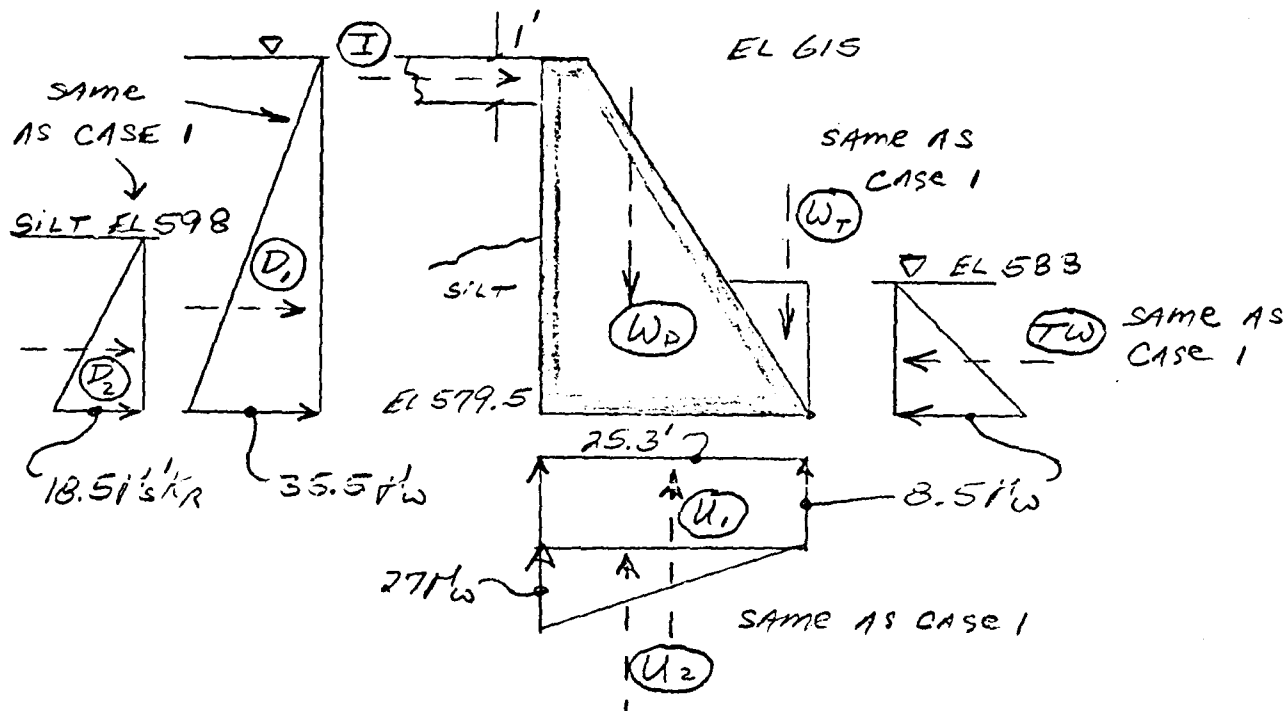
CASE 2 Normal pool plus ice load. Use ice load of 5 k/ft for ice 1' thick.
OVERTURNING

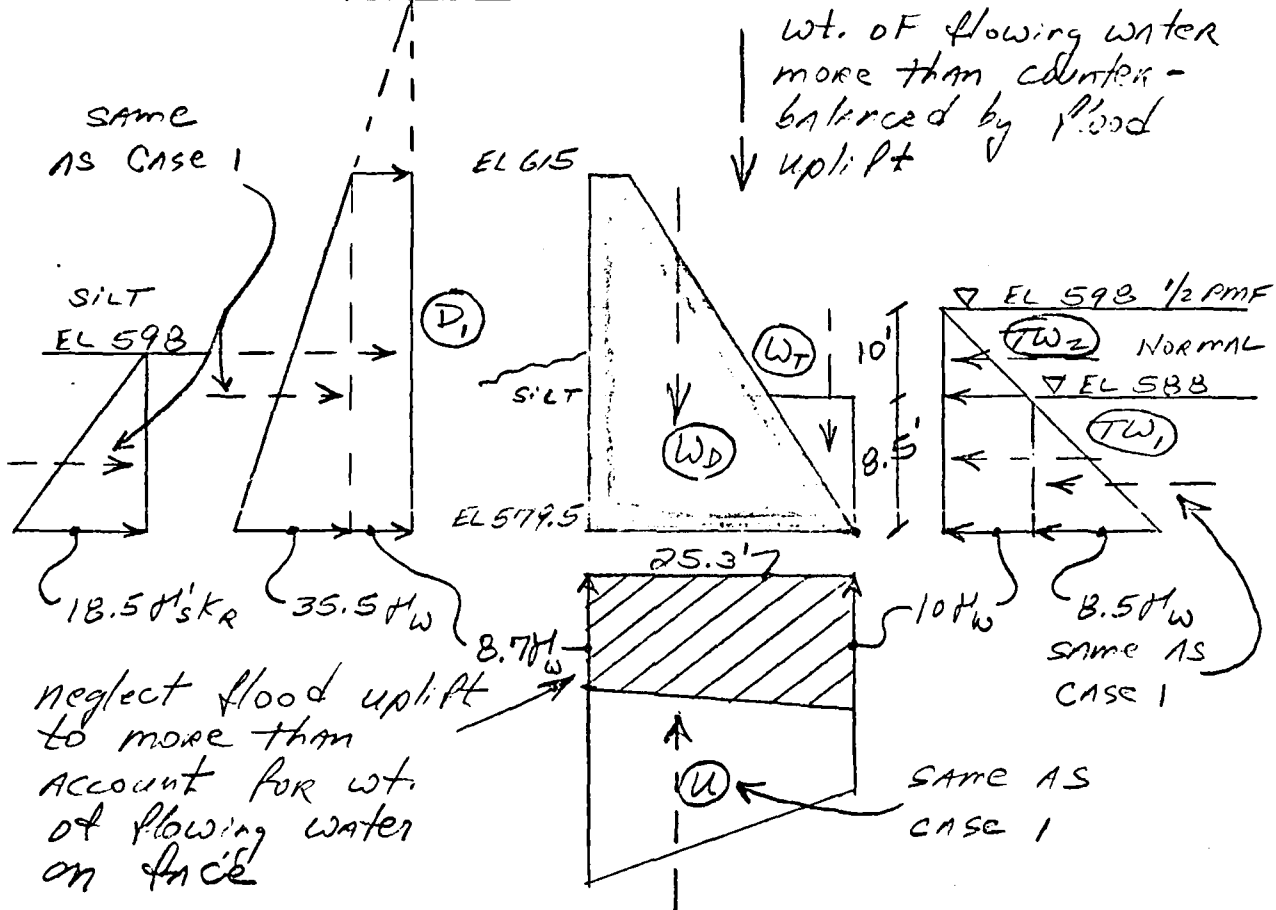
CASE 3 - 1/2 PMF pool, full HW & TW uplift, remainder same as Case 1.
